**Materials Assessment and Maintenance Manual
for Common Areas**

San Francisco, California

Architectural Resources Group (ARG) was contracted to conduct a conditions survey of common areas for 450 Post Street in San Francisco (the “building”). This report includes a maintenance manual for the preservation of the building’s exterior architectural elements and selected interior spaces, and is based on a visual survey of the building.

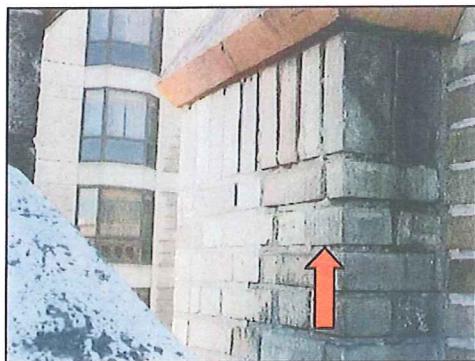
Deteriorated mortar joints are typical at front parapet wall returns.

- Clean the façade to remove soiling and reveal potentially hidden deterioration such as open joints in the masonry
- Seal cracks at the tower corners and between brick and terra cotta masonry; monitor the cracks to see if they open again (water could get in through the cracks)
- Repoint deteriorated mortar joints at the towers
- Install sealant at joints between buildings

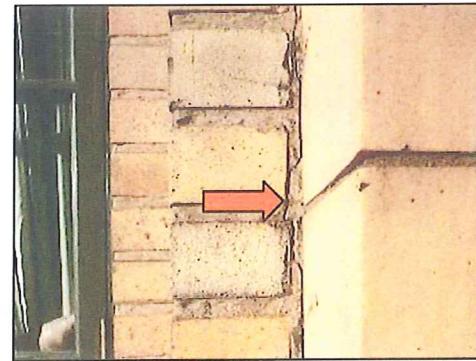
Long vertical cracks visible at the corners of each tower may be caused by differential movement between adjacent masonry elements, or by corrosion of underlying steel columns; further investigation will be necessary to determine this. Cracking also occurs between the brick masonry and adjacent terra cotta pilasters at the balcony. In general, the brick masonry is in good condition, with no other major areas of cracks, spalls, brick failures, or salt deposits (known as efflorescence). Efflorescence is the crystallization of soluble salts on surfaces, indicating the movement of water through porous materials. Small anchor holes and isolated areas of abrasions are found throughout the building. Mortar joints appear to be in fair condition overall, but joints at the towers are weathered and eroded and in poor condition. Front parapet returns show poor repointing and partially cut joints that were never repointed. Graffiti was also observed at the west parapet return. The spaces between 450 Post Street and adjacent buildings on both sides show deteriorated sealant joints. *Brick masonry, such as the exterior brick cladding and all sealant and mortar joints, should be inspected on an annual basis every June.*

Cracks are common between brick and terra cotta masonry.

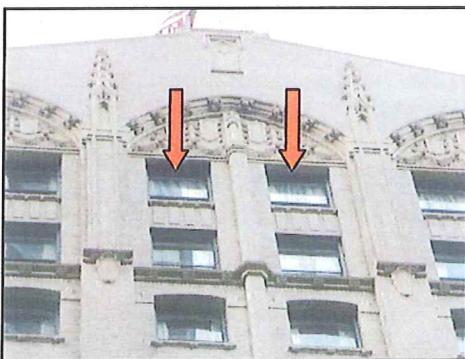
The exterior terra cotta cladding appears to be in overall fair condition, including coping at the front parapet and towers. Aside from the damage at the 3rd floor balcony, the most significant deterioration occurs at the 12th floor window headers, where cracks in the terra cotta units are potentially caused by the corrosion of underlying steel lintels. Elsewhere, mortar joints are deteriorated and there are minor instances of spalls, where the terra cotta glaze surface is detached from the clay body. Efflorescence is visible at some of the glaze spalls and in some small open anchor holes. Soiling is especially heavy at the undersides of third floor arches and headers and at horizontal stringcourses on the south elevation, as well as at tower stringcourses and coping. Several terra cotta units are missing from the façade, including a lattice piece and a decoration at the entrance. A crack remains in the sill at the location of the missing ornamental piece. In addition, four elements of unknown design below the tower parapets appear to have been removed. A metal flagpole anchorage attached to terra cotta cladding above the entrance is corroding. *Terra cotta masonry should be inspected on an annual basis every June.*

Terra cotta window headers at the 12th floor are cracked.

- Repair and restore the 3rd floor balcony and balustrade
- Investigate and repair the cause of cracked window headers at the 12th floor
- Repair cracked terra cotta units and repoint deteriorated mortar joints
- Install lead T-caps at parapet coping joints to minimize water infiltration
- Restore missing terra cotta ornamental units
- Coat glaze spalls to prevent moisture intrusion

- **Balcony:** The third floor terra cotta balcony and balustrade should be repaired and restored.
- **Further Investigation (Masonry):** Vertical cracks in the tower masonry and cracked terra cotta window headers should be investigated to determine whether underlying steel is corroding.

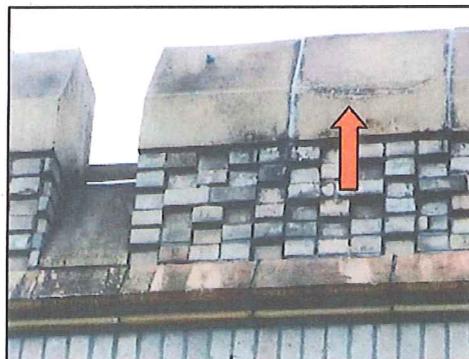
Soiling and deteriorated mortar are typical at the towers parapets.

- **Deferred Maintenance (Windows and Doors):** Wood and steel windows and doors at the upper roof areas are deteriorated and should be rehabilitated.
- **Deferred Maintenance (Masonry):** Deteriorated mortar in parapets should be replaced.

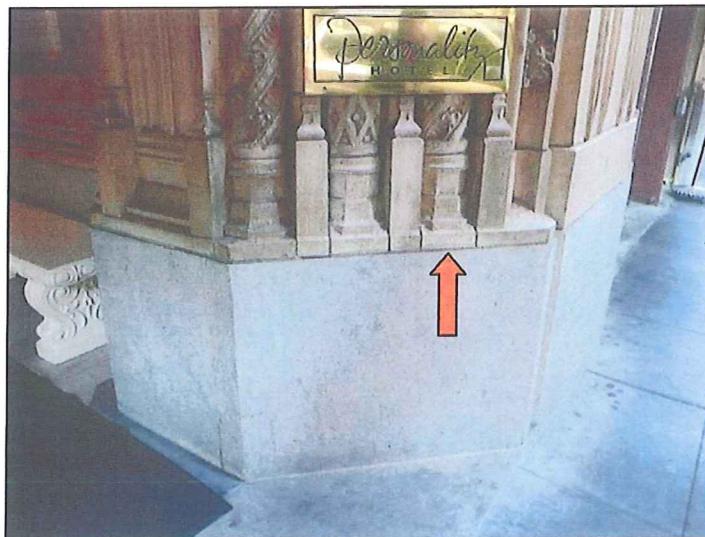
The granite base found at the front building façade is in good condition. No major cracks, spalls or displacement was observed, but light staining and abrasions occur throughout. Mortar joints are in fair condition, showing cracks and voids typical at joints between granite and terra cotta. Joints between granite base and concrete sidewalk and other flooring appeared to be in good condition. *Granite base and joints should be inspected once a year in June.*

Mortar joints between the granite base and terra cotta elements are typical locations of deterioration.

- Repoint deteriorated mortar joints
- Maintain sealant joints at the sidewalk to prevent water infiltration

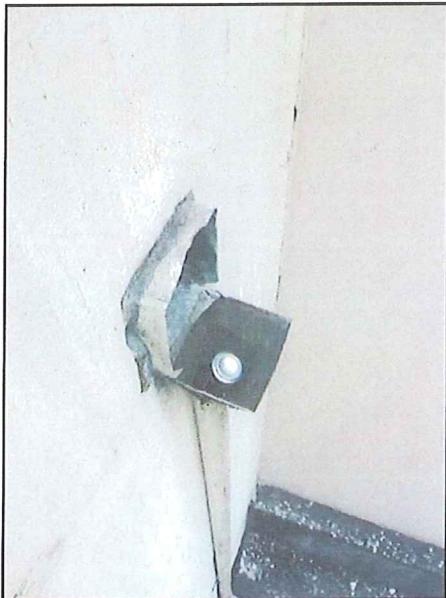
A downspout draining a 4th floor roof is obstructed by a soft drink can.

- Clean obstructed gutters, scuppers, and downspouts, and install gutter covers
- Replace missing and deteriorated drainage elements (downspouts, leader heads, etc)
- Initiate weekly litter policing to prevent accumulation of debris
- Paint or replace corroding steel railings, bracing, flashing, and sheet metal ducts and vents
- Replace lower roofs within the next 5 years

- **Deferred Maintenance (Roofing):** Obstructed gutters, downspouts, and drains should be cleaned out. Corroded and missing sheet metal elements should be replaced or repaired and painted. Corroding fire escapes should be painted.

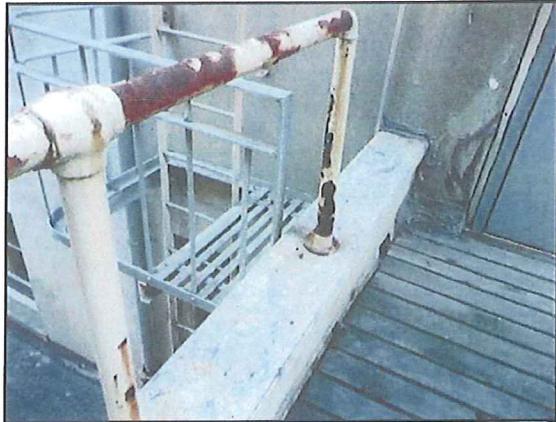
Corroding pipe rails protecting elevated walkways present a life safety hazard.

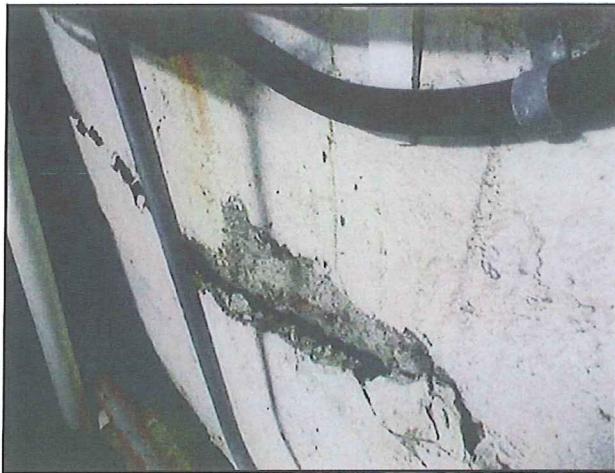
The concrete foundation wall in the sub-basement below the pool exhibits cracking and spalling of the concrete that is exposing underlying reinforcing metal. Efflorescence, corroding pipes, and new concrete patching suggest that excessive moisture is a perennial problem here.

Cracked plaster is falling off a wall in the sub-basement, exposing underlying reinforcing metal to corrosion.

- Patch the foundation wall in the sub-basement to prevent further corrosion of reinforcing metal
- Repair cracks in parapet walls
- Remove extraneous anchors and straps from the parapet walls
- Clean and re-paint concrete parapet walls and metal bracing

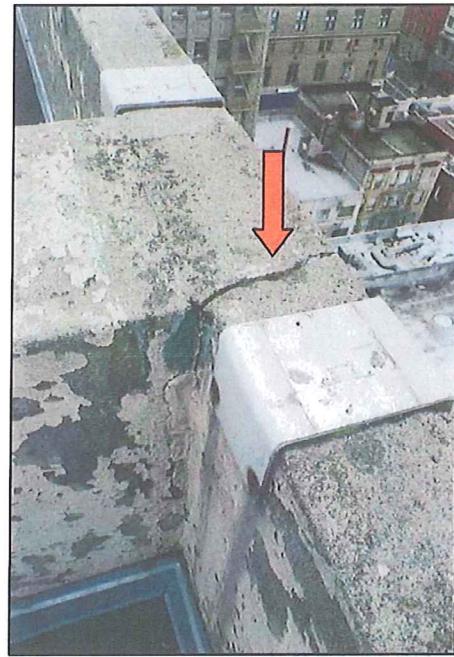
Exterior concrete walls, mainly at parapets, are in fair condition. At the upper roof, minor cracks and spalls at the north parapet wall are visible where an aluminum framed wind barrier has been installed. Metal anchor straps on the parapet have corroding fasteners that conduct moisture into the wall. Biological growth is prevalent at top ledges, in cracks, and on adjacent wall surfaces that have peeling paint. At the south parapet wall and diagonal bracing, peeling paint and minor cracks caused by moisture intrusion are prevalent. Biological growth is also present at joints between the bracing and wall, and water staining is visible beneath the horizontal beam and diagonal bracing. *Concrete walls and diagonal bracing should be inspected annually in September.*

On the north parapet wall, cracks and corroding metal strap fasteners are entry points for moisture penetration that can corrode underlying reinforcing metal.

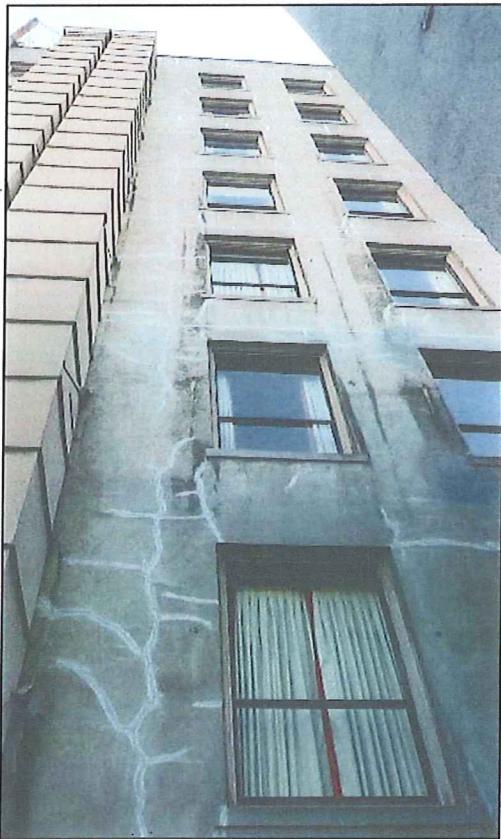
Painting walls will protect cement plaster from excessive soiling and prolong the life of sealants applied to cracks.

- Seal cracks in cement plaster
- Clean and paint cement plaster walls, as well as metal downspouts and flashing

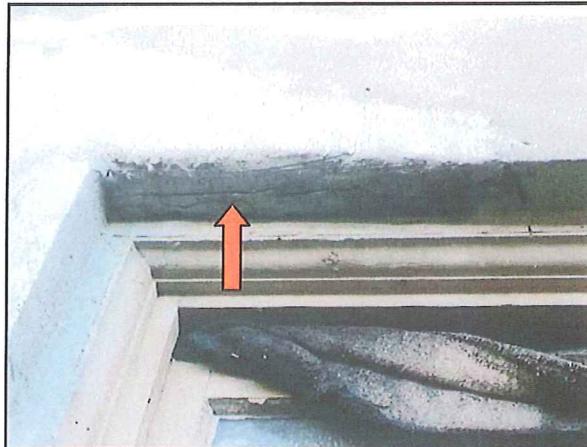
Moisture is continuing to penetrate the cement plaster, where the corrosion and expansion of underlying metal window lintels is cracking recent patches and causing them to de-bond.

- **Deferred Maintenance (Concrete Walls):** Spalls and cracks in concrete and cement plaster walls should be patched and sealed and the walls painted with an appropriate primer and topcoat system.

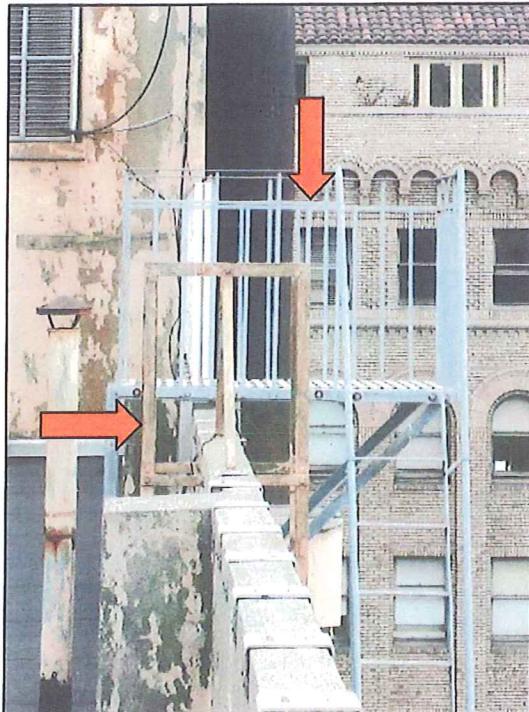
Painted, non-galvanized steel access ladders are older than the galvanized, uncoated fire escapes. Corrosion is a typical condition found at older non-galvanized ladders, especially in areas of paint loss and at anchors.

- Paint non-galvanized fire escapes
- Repair or replace corroded fire escapes components, and repaint
- Repair walls at anchorage points to protect life safety

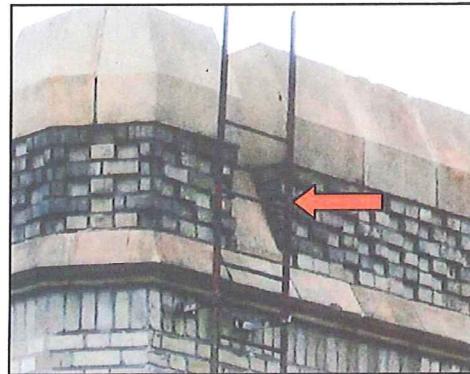
Corrosion of non-galvanized, steel access ladders is common.

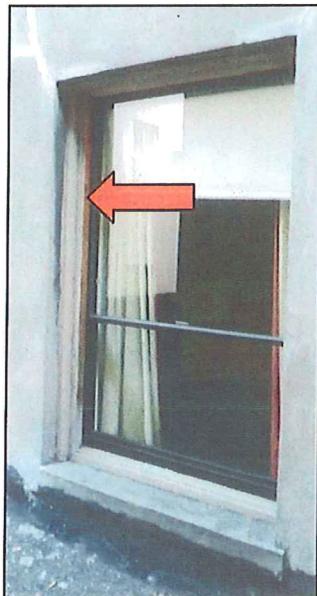
Aluminum window with
unpainted wood trim

Windows were observed from the ground using binoculars, from selected interior spaces, and at close range from roof tops. Original wood windows are located at the bottom floors of the south elevation, mainly in spaces occupied by the Elks Lodge and Post Street Theatre, and typically have a terra cotta surround and sill. Newer, aluminum windows with concrete sills on the upper floors and in Kensington Hotel spaces are generally in good condition. Overall, wood and aluminum windows and frames appear to be in good condition. Wood windows at theatre foyer are in operable condition, but corrosion is visible at the frames of interior metal wind baffles. Minor cracks and spalls are visible at concrete sills. Wood trim around windows on the north side (rear) of the building are unpainted and show water stains.

- Rehabilitate deteriorated wood and steel windows
- Apply coatings to unpainted wood trim
- Repair and paint corroded skylight frames
- Repair cracks in concrete at window openings

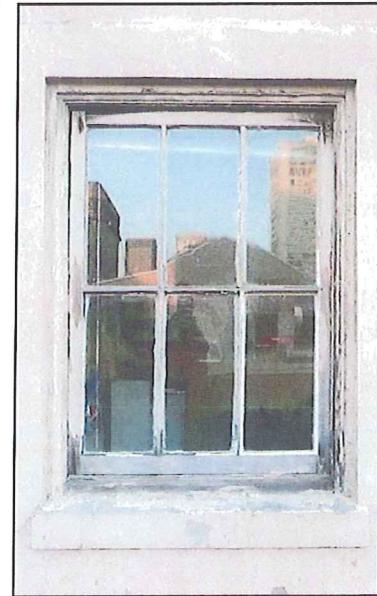
Wood window (penthouse)

Wood windows at penthouses and at the fifth floor are in poor condition showing peeling paint, raised grain, missing glazing putty and in one location, penetrations for piping. Despite these conditions, windows are salvageable. Cracks around penthouse window openings are common. Aluminum louvers, grilles and frames at the penthouses and front building facade are unpainted and in fair condition, showing slight corrosion and paint loss.

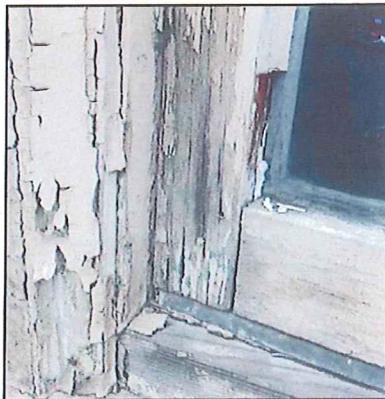
Typical conditions at penthouse wood windows include missing putty, paint loss, and splitting and separation of the sash.

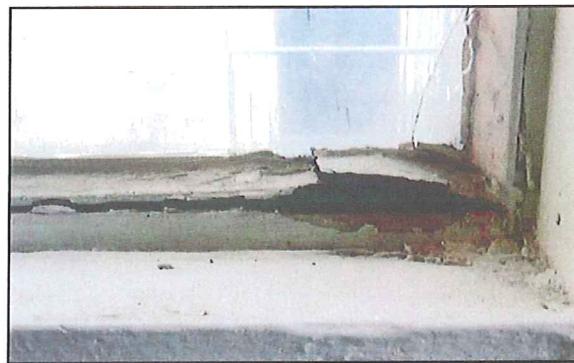
Typical deterioration at steel windows includes cracked glass, corrosion scaling, and paint loss.

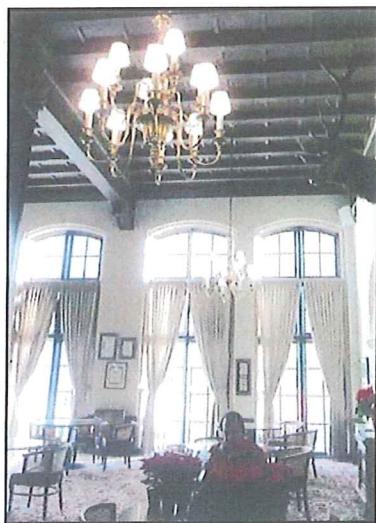
Exterior wood French doors with multi-lite transoms leading to the third floor balcony are generally in fair condition. In some locations, hardware does not align properly. During the investigation, the lack of exterior door hardware made it difficult to return indoors. Similar doors line the north wall of the building on the same floor, in the Ballroom. Hardware for these doors was recently restored and doors in general appear to be in good condition. None of the wood French doors had weather stripping.

French doors at the third floor balcony are accessible from the Lounge.

- Ensure doors to the unstable third floor balcony remain locked at all times
- Rehabilitate corroding metal doors at penthouses
- Install weather stripping at third floor balcony French doors to minimize heat loss
- Rehabilitate French doors at third floor balcony after balcony is stabilized or restored

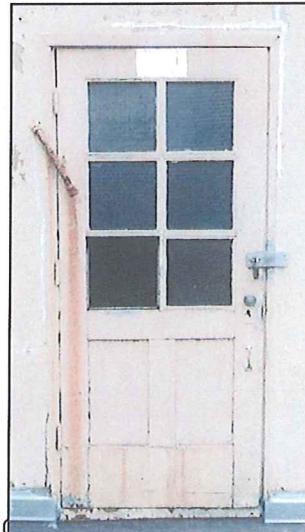
Metal clad wood door

Metal and metal-clad wood doors at penthouses are in poor condition, showing corrosion staining, deteriorated wood and missing glazing units. Painted and unpainted metal awnings over some metal doors are in fair condition and do not show any major deterioration. Contemporary metal and glass doors at the building entrances on the ground floor are in good condition. An ornate multi-lite transom over the Hotel entrance doors appears to be in good condition. *Exterior doors, including doors leading to third floor balcony and fire escape should be inspected annually every April.*
