**Materials Assessment and Maintenance Manual
for Common Areas**

San Francisco, California

Architectural Resources Group (ARG) was contracted to conduct a conditions survey of common areas for 450 Post Street in San Francisco (the “building”). This report includes a maintenance manual for the preservation of the building’s exterior architectural elements and selected interior spaces, and is based on a visual survey of the building.

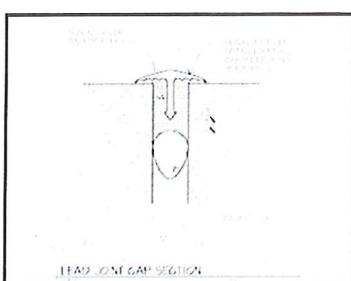
This detail drawing shows how lead joint caps ("T-caps") can be installed at sky-facing parapet terra cotta joints to prevent water intrusion.
